東京消防庁

When replacing a straight LED lamp with a fluorescent light fixture

Incorrect combination may lead to a fire.

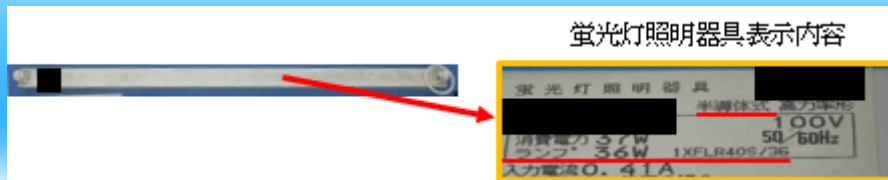
In addition, there are also rapid-start and starter types.

Even if the lamp is labeled the same, some fluorescent luminaires may not be compatible, depending on their specifications.

Check both the lamp and the fluorescent light fixture before you replace it yourself. For now, I installed it and it lit up without any problems.

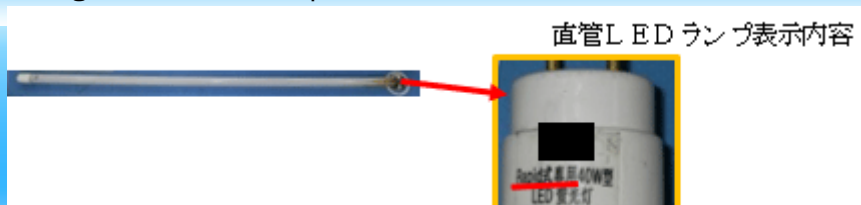
Straight-tube LED lamps

このほかに、スタータ式などがあります。

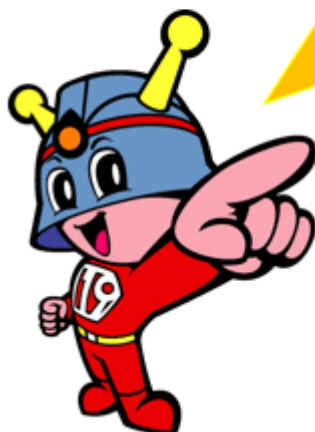
Burnout

The board is receiving so much heat that it is ashen.

LEDランプを交換する場合は、蛍光灯照明器具の表示内容を確認してね！！
